## Fire Testing of Exterior Wall Systems

*Investigative testing conducted in accordance with the test methodology described in CSFM 12-7A-1, Materials and construction methods for exterior wildfire exposure – Exterior wall siding and sheathing*

**Nominal 1x6 V-Rustic T&G Maximo Thermo BurnBlock**  
**7/16" OSB Sheathing**

**WFCi Report #25065a**

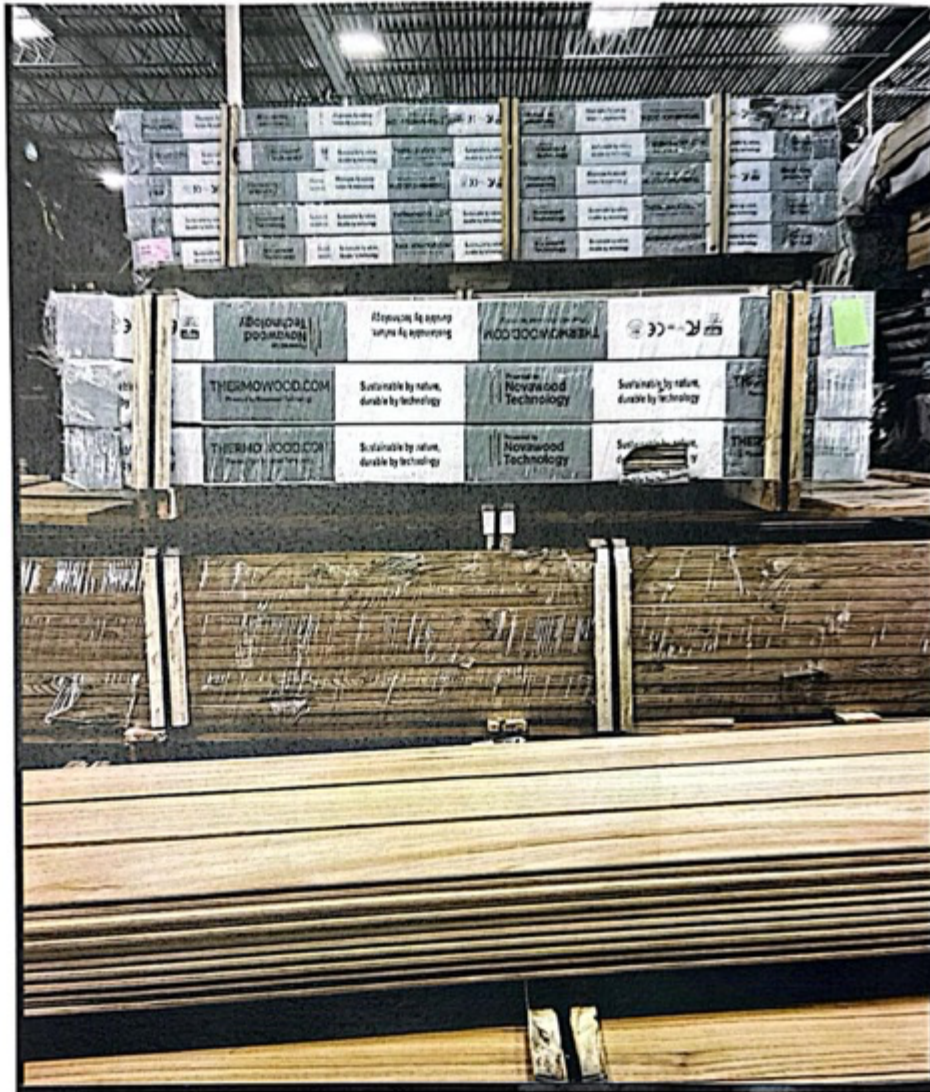
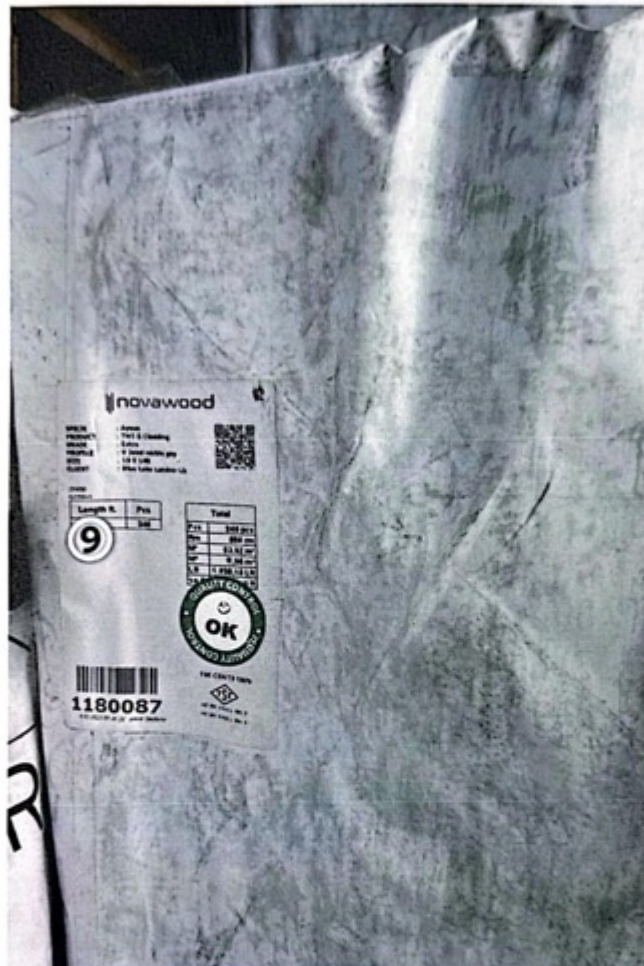
- Bundle seen below selected for Testing:

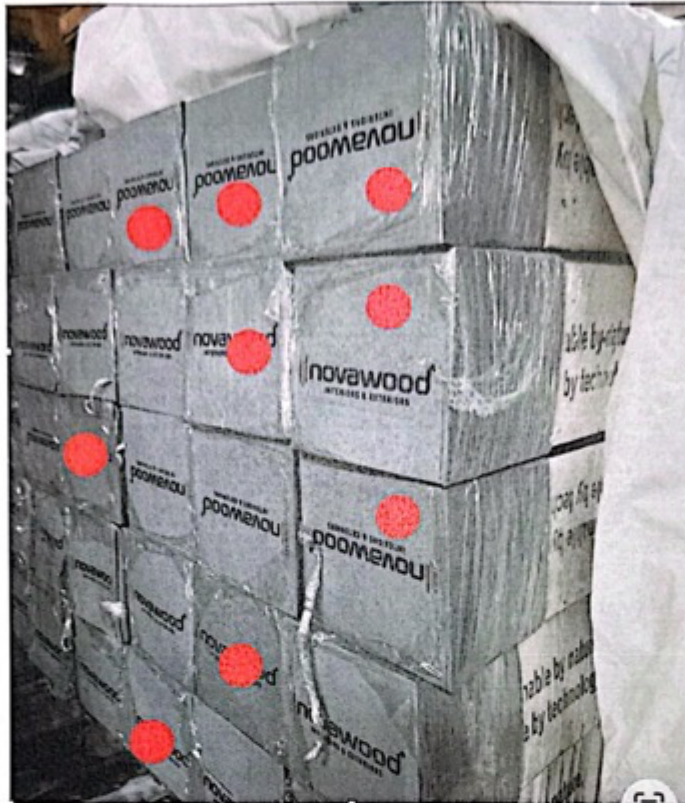
Images of elected packages for testing:
